## Golden Gate Dam Site

## Dam Site Geology

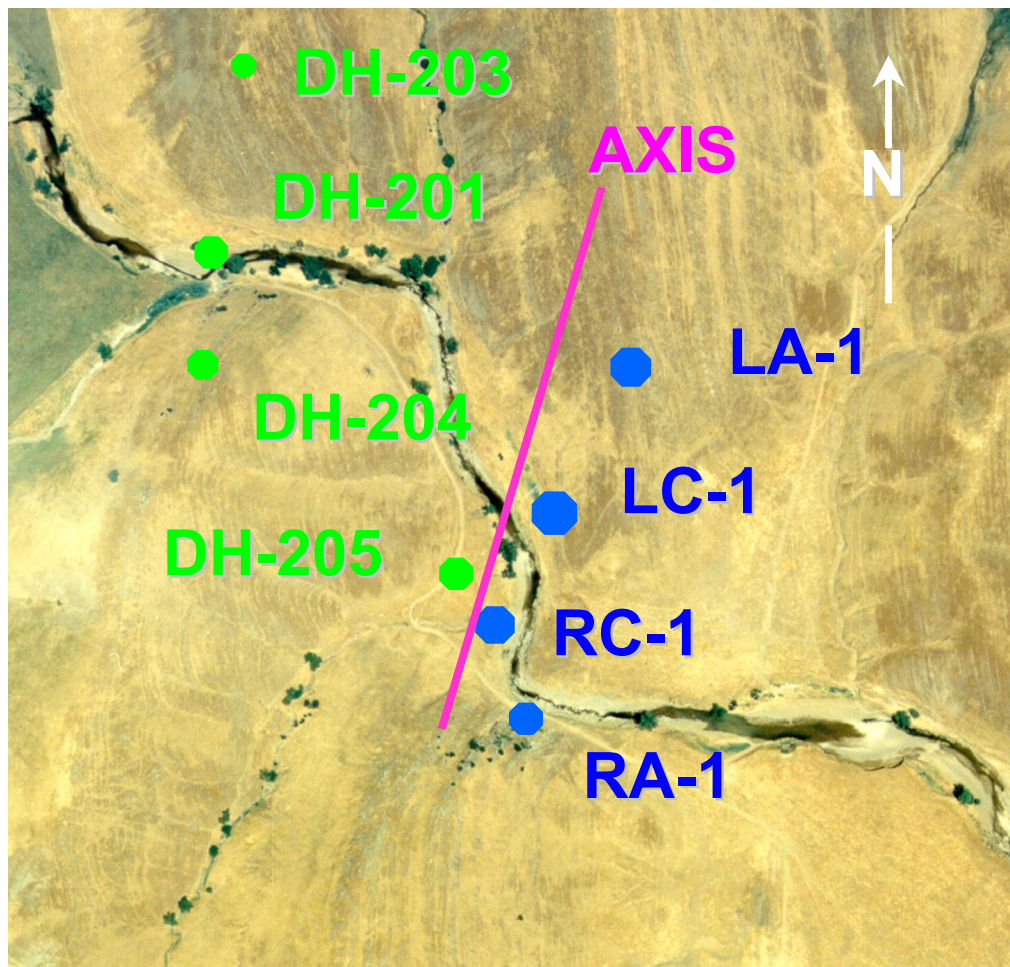
Photo 9. Aerial view of Golden Gate Dam site on Funks Creek with the downstream axis and drill holes

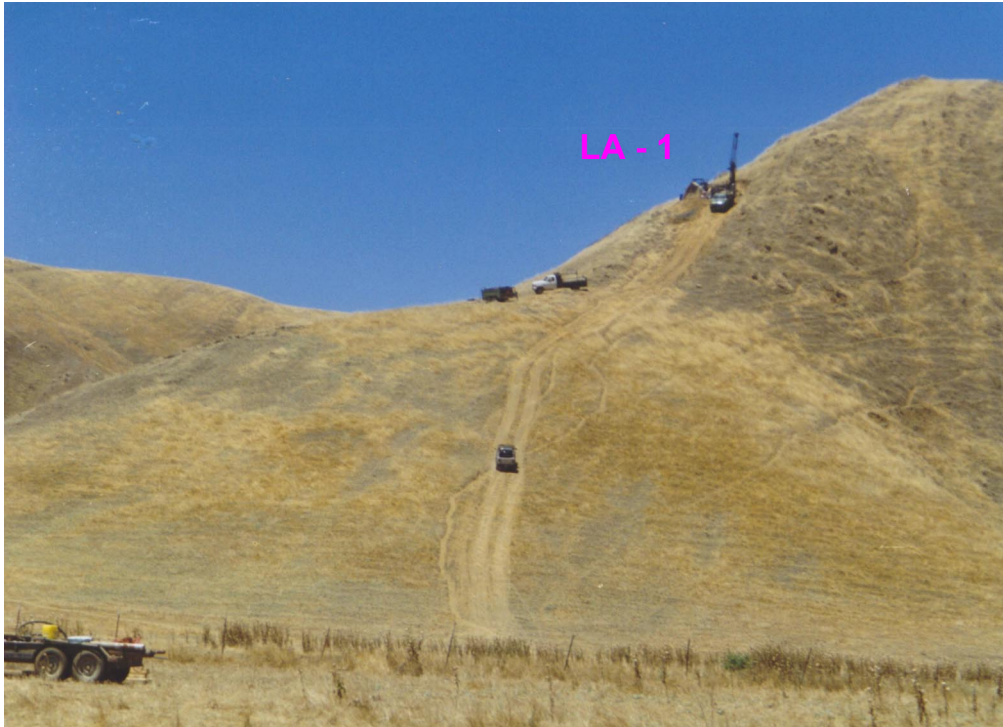
Vertical drill hole LA-1 was drilled to a depth of 248.8 feet to evaluate the sandstone and mudstone underlying the left abutment (Photo 11). No core was recovered from 0.0 to 4.6 feet. The sandstone was generally hard. From 4.6 to 12.6 feet, it drilled through 70 percent mudstone with 30 percent sandstone interbeds. From 12.6 to 47.2 feet, it intersected 100 percent sandstone. From 47.2 to 157.4 feet, the hole drilled through 80 percent mudstone with 20 percent sandstone interbeds. From 157.4 to 248.8 feet, the hole intersected 85 percent sandstone with 15 percent mudstone interbeds. From 125.1 to 128.8 feet, a bedding plane shear with associated gouge and slickensides was encountered. Some minor shears were encountered at 166.0, 197.4, 245.0, and 246.6 feet.

**Photo 11. CME-850 drill rig at Golden Gate Dam site drill hole LA-1**

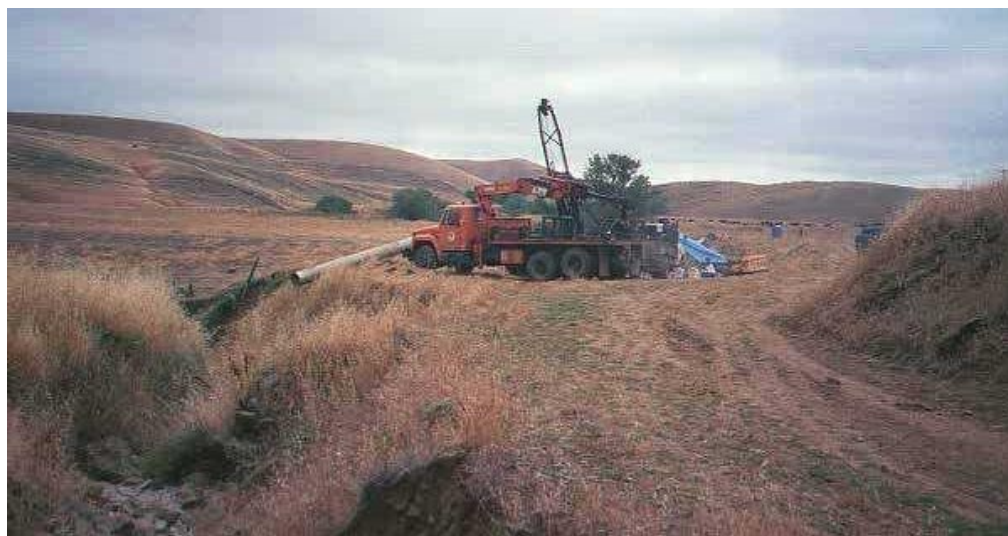
Angle hole RC-1 was drilled at 45 degrees to a depth of 134.6 feet to intercept the GG-2 fault as mapped and to evaluate associated permeability in the foundation (Photo 12). It encountered sandy clay terrace deposits in the initial 32.4 feet. From 32.4 to 123.9 feet, the hole encountered intense fracturing, gouge, and slickensides. It intersected 75 percent mudstone with 25 percent sandstone interbeds. The hole drilled through 100 percent sandstone from 123.9 to 134.6 feet. A 26.4-foot zone of intense fracturing, gouge, and slickensides that probably represents the GG-2 fault was encountered from 73.0 to 99.4 feet (Photo 13). Another zone of intense fracturing that may be related was encountered from 32.4 to 58.1 feet.

Photo 12. CME-850 drill rig at Golden Gate Dam site angle drill hole RC

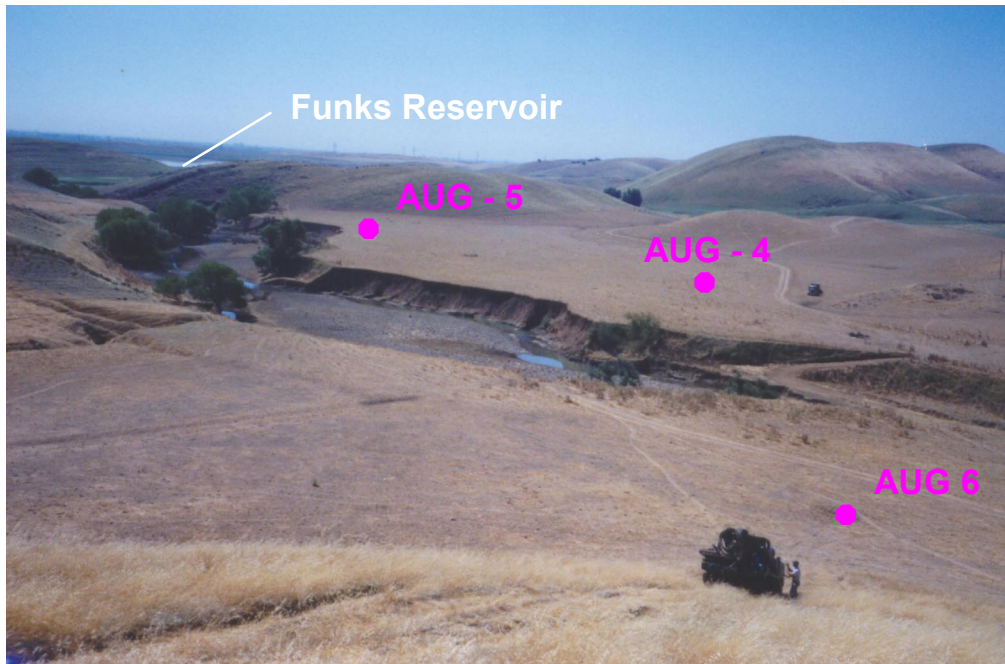
**Photo 14. Auger holes on terraces downstream of Golden Gate Dam site**
